**Flood Control Project Maintenance
Levee Inspections**

Spring 2014 Levee Inspection Results

City of Sacramento

Levee Inspection Report By Mile - Spring 2014

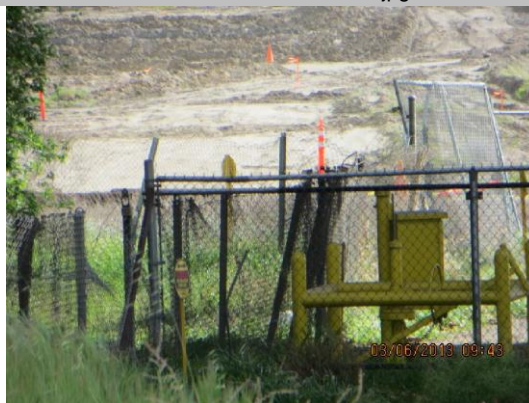
Photo 1 of 1 : UCIP_2150.jpg

LM Start	0.06	Rating **	M	Issue No.	15
LM End	0.06	Issue Type +	En	Location *	CR
Category	Supplemental			GPS Latitude/Longitude	
				Start	End
Item	DWR UCIP Field Study			38.589864 °	38.589864 °
				-121.505128 °	-121.505128 °
DWR ID	DWR_NA0005_01_s _ 2014_15				
Action/Comments					
Inspector Comments: FS_ID:19967					
EP_NO: 14527					
Repair Type:					
Crossing Status:					
UCIP Comments: Need to contact owner to determine condition of crossing and last inspection date.					
FIELD_STRUCT_DESC: 12-inch diameter pipeline under channel through levee, 44 feet below the crown. Southern Pacific Pipe Lines. (Permit No. 14527, Southern Pacific Pipelines, Inc.-1987).					
FS Date: 3/6/2013

View of multiple markers indicating gas alignment.

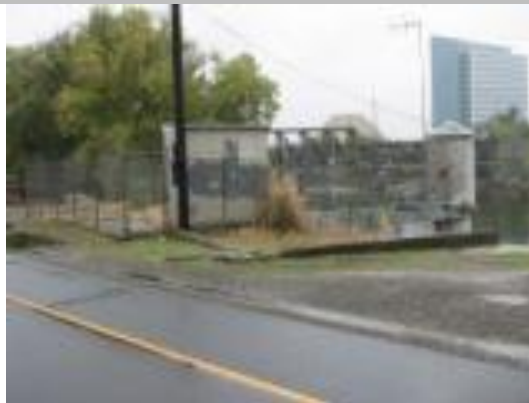
Photo 1 of 1 : johngw_s_20140429_919.jpg

LM Start	0.14	Rating **	A	Issue No.	1
LM End	0.14	Issue Type +	Ob	Location *	WS
Category	Earthen Levee			GPS Latitude/Longitude	
				Start	End
Item	Encroachments			38.588715 °	38.588715 °
				-121.504885 °	-121.504885 °
DWR ID	DWR_NA0005_01_s _ 2012_1				
Action/Comments					
Building					
Inspector Comments: Fenced area around State (DWR) recorder can.

View of the I Street recorder can.

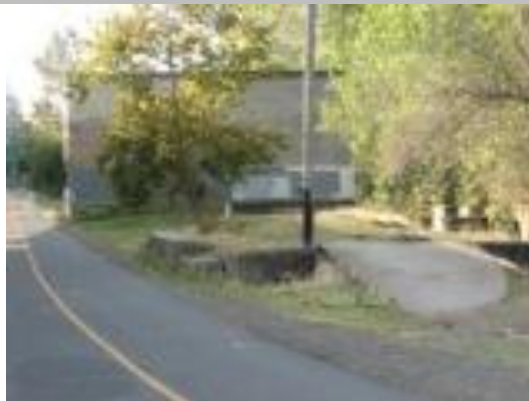
Photo 1 of 2 : johngw_s_20140429_920.jpg

LM Start	0.22	Rating **	A	Issue No.	2
LM End	0.22	Issue Type +	Ob	Location *	WS
Category	Earthen Levee			GPS Latitude/Longitude	
				Start	End
Item	Encroachments			38.587592 °	38.587592 °
				-121.504892 °	-121.504892 °
DWR ID	DWR_NA0005_01_s _ 2012_2				
Action/Comments					
Building					
Inspector Comments: Historical building.

Historical Building with foundations and ramps on upstream and downstream sides. Fall 2011

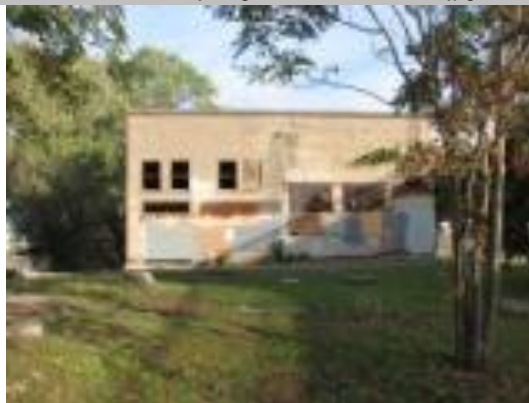
Photo 2 of 2 : johngw_s_20140429_921.jpg

A view of the south side of the building. Fall 2011

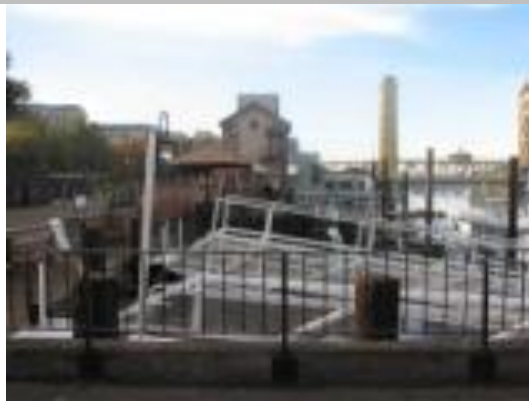
Photo 1 of 3 : johngw_s_20140429_941.jpg

LM Start	0.37	Rating **	A	Issue No.	14
LM End	0.73	Issue Type +	Ob	Location *	CR
Category	Earthen Levee			GPS Latitude/Longitude	
				Start	End
Item	Encroachments			38.585525 °	38.580445 °
				-121.505338 °	-121.506966 °
DWR ID	DWR_NA0005_01_s _ 2012_14				
Action/Comments					
Building

Photo looking downstream from the Delta King in Old Sacramento.

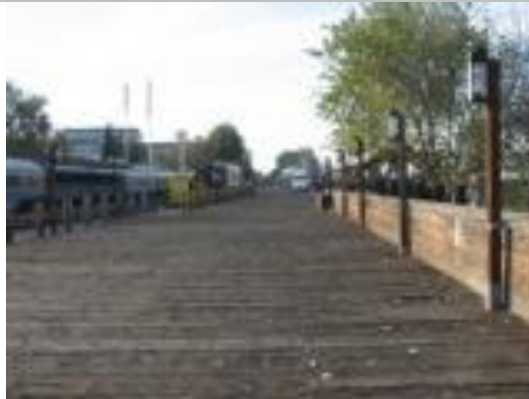
Photo 2 of 3 : johngw_s_20140429_942.jpg

LM Start	0.37	Rating **	A	Issue No.	14 (cont)	
LM End	0.73	Issue Type +	Ob	Location *	CR	
Category	Earthen Levee			GPS Latitude/Longitude		
				Start	End	
Item	Encroachments			38.585525 °	38.580445 °	
				-121.505338 °	-121.506966 °	
DWR ID	DWR_NA0005_01_s _ 2012_14					
Action/Comments						
Building						
Inspector Comments: This is the Old Sacramento flood wall. This part is a walking inspection. The vegetation along the waterside of the floodwall has been removed.

The wooden boardwalk in Old Sacramento on top of the flood wall. Fall 2011

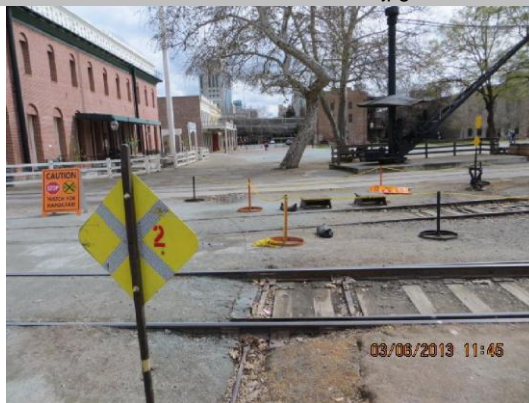
Photo 1 of 1 : UCIP_2218.jpg

LM Start	0.42	Rating **	M	Issue No.	17
LM End	0.42	Issue Type +	En	Location *	CR
Category	Supplemental			GPS Latitude/Longitude	
				Start	End
Item	DWR UCIP Field Study			38.584762 °	38.584762 °
				-121.505556 °	-121.505556 °
DWR ID	DWR_NA0005_01_s_2014_17				
Action/Comments					
Inspector Comments: FS_ID:20384

View of landward side close to railroad museum.

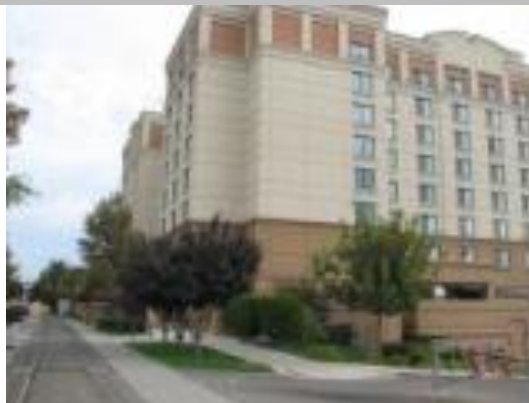
Photo 1 of 1 : johngw_s_20140429_925.jpg

LM Start	0.78	Rating **	A	Issue No.	4
LM End	0.78	Issue Type +	Ob	Location *	CR
Category	Earthen Levee			GPS Latitude/Longitude	
				Start	End
Item	Encroachments			38.579712 °	38.579712 °
				-121.507347 °	-121.507347 °
DWR ID	DWR_NA0005_01_s_2012_4				
Action/Comments					
Building Inspector Comments: Embassy Suites

Embassy Suites

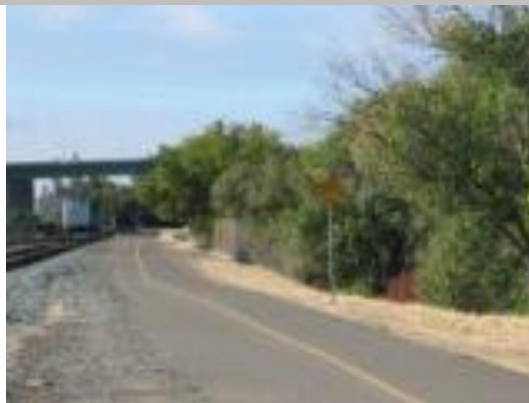
Photo 1 of 3 : johngw_s_20140429_938.jpg

LM Start	1.15	Rating **	A/W	Issue No.	13
LM End	1.69	Issue Type +	Ma	Location *	WS
Category	Earthen Levee			GPS Latitude/Longitude	
				Start	End
Item	Vegetation			38.574780 °	38.568757 °
				-121.510191 °	-121.515930 °
DWR ID	DWR_NA0005_01_f_2012_13				
Action/Comments					
Trees / Woody Vegetation

Trees and brush are larger than 2 inches but does not effect visibility.
Photo fall 2012.

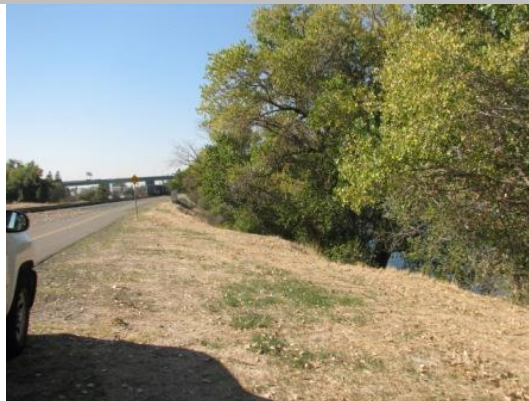
Photo 2 of 3 : johngw_s_20140429_939.jpg

Monitor the trees and woody vegetation along the rivers edge. Fall 2013

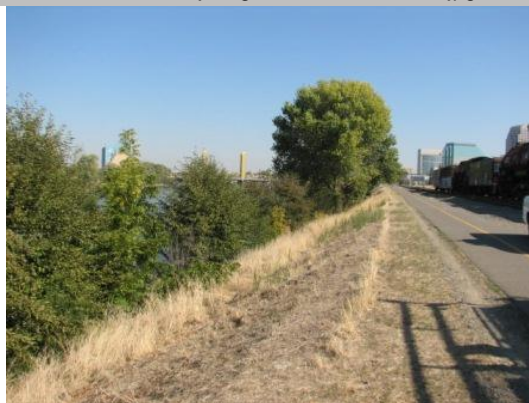
Photo 3 of 3 : johngw_s_20140429_940.jpg

Monitor the trees and vegetation along the rivers edge. Fall 2013

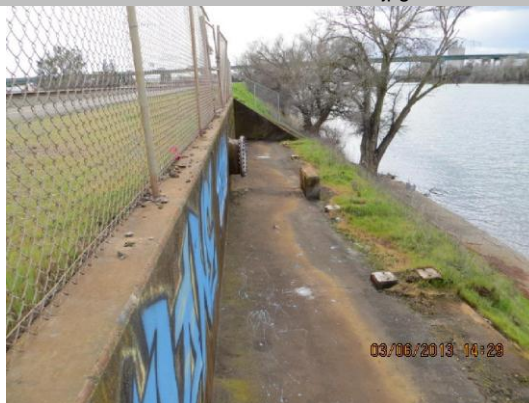
Photo 1 of 1 : UCIP_2190.jpg

LM Start	1.23	Rating **	M	Issue No.	18
LM End	1.23	Issue Type +	En	Location *	WS
Category	Supplemental			GPS Latitude/Longitude	
				Start	End
Item	DWR UCIP Field Study			38.573900 °	38.573900 °
				-121.511025 °	-121.511025 °
DWR ID	DWR_NA0005_01_s_2014_18				
Action/Comments					
Inspector Comments: FS_ID:20184

Headwall with 1 crossing capped off.

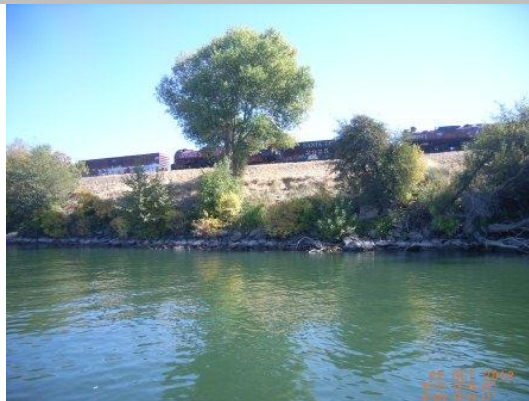
Photo 1 of 2 : USACE2013A_SAC_58-5_L_5.jpg

LM Start	1.31	Rating **	M	Issue No.	12
LM End	1.39	Issue Type +	Ma	Location *	WS
Category	Supplemental			GPS Latitude/Longitude	
				Start	End
Item	USACE Erosion Survey			38.573169 °	38.572277 °
				-121.511998 °	-121.513063 °
DWR ID					
Action/Comments					
Inspector Comments: 2008 - Oversized levee, should be repaired under maintenance. 2009 - Shallow slumps at the mid bank. 2010 - Some minor erosion at the toe, likely from wave wash. Some new shallow slumps. 2011 - One new tree has fallen. 2013: Erosion continues on the slope surface, site extended upstream [2013 Site ID: SAC_58-5_L]

USACE 2013 Photo #1

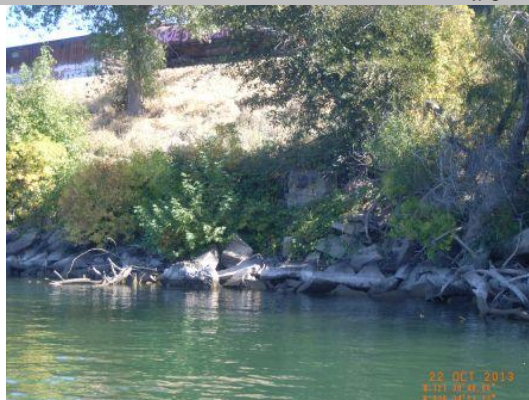
Photo 2 of 2 : USACE2013A_SAC_58-5_L_6.jpg

USACE 2013 Photo #2

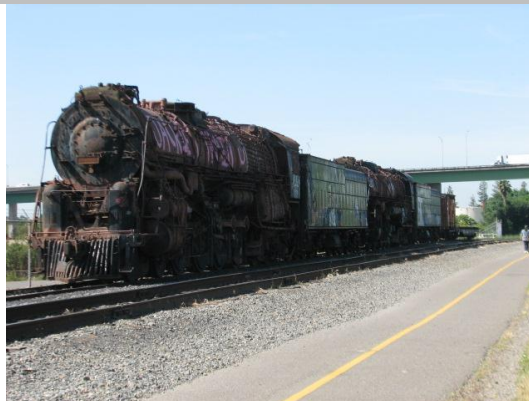
Photo 1 of 1 : johngw_s_20140502_963.jpg

The train cars have been relocated upstream on the levee. Spring 2014

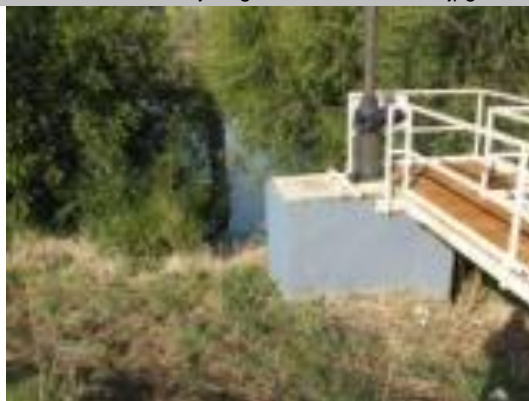
Photo 1 of 1 : johngw_s_20140429_926.jpg

The screw gate is the positive closure for the pipe. Fall 2011

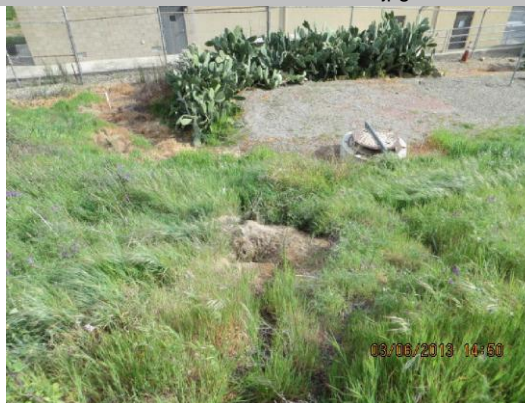
Photo 1 of 1 : UCIP_2183.jpg

LM Start	1.41	Rating **	M	Issue No.	19
LM End	1.41	Issue Type +	En	Location *	WS
Category	Supplemental			GPS Latitude/Longitude	
				Start	End
Item	DWR UCIP Field Study			38.572019 °	38.572019 °
				-121.513082 °	-121.513082 °
DWR ID	DWR_NA0005_01_s _ 2014_19				
Action/Comments					
Inspector Comments: FS_ID:20105					
EP_NO: N/A					
Repair Type:					
Crossing Status:					
UCIP Comments: Dense vegetation limits the inspector's visibility to identify signs of pipe failure (leaks) along the waterward and landward slope. Recommend removing vegetation along pipe alignment to conduct proper inspection of structure and appurtenances.					
FIELD_STRUCT_DESC: 1 of 3: 6-inch pipe through the levee, 8 feet below the crown. Gate valves on the waterward slope. Manhole located on landward berm.					
FS Date: 3/6/2013

View of landward side where crossing should be running through.

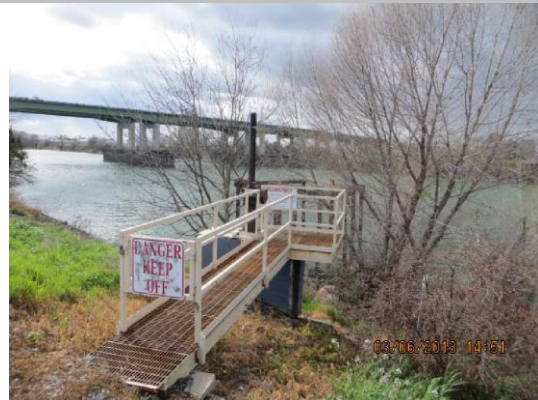
Photo 1 of 1 : UCIP_2169.jpg

LM Start	1.43	Rating **	M	Issue No.	26
LM End	1.43	Issue Type +	En	Location *	WS
Category	Supplemental			GPS Latitude/Longitude	
				Start	End
Item	DWR UCIP Field Study			38.571790 °	38.571790 °
				-121.513323 °	-121.513323 °
DWR ID	DWR_NA0005_01_s _ 2014_26				
Action/Comments					
Inspector Comments: FS_ID:20087 EP_NO: 12196 Repair Type: Crossing Status: UCIP Comments: Vault located on levee crown (bike path) and siphon breaker located on waterward shoulder. Coordinate with City of Sacramento to determine the condition of this crossing and last inspection. FIELD_STRUCT_DESC: 1 or 2: 42-inch RCP wash water intake pipe through levee at approximately 10 feet below crown. Line extends approximately 145 feet waterward from the reservoir to the outfall structure at the waterward shoulder of the levee. Pipe is skewed approximately 12 degrees upstream. Water Intake structure with screen. Waterward slope is armored by rock slope protection. Rock slope protection perimeter exists at river intake. (Permit No. 12196, Sacramento Regional County Sanitation District-1981). Permit 16611 was issued in 1996 to reline the inside of the pipe. FS Date: 3/6/2013

Walkway present on waterward shoulder.

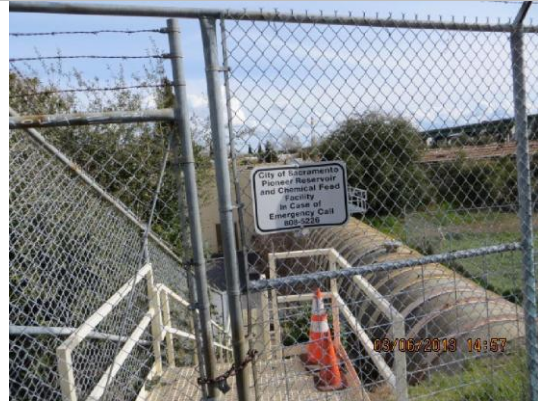
Photo 1 of 1 : UCIP_2181.jpg

LM Start	1.43	Rating **	M	Issue No.	27
LM End	1.43	Issue Type +	En	Location *	WS
Category	Supplemental			GPS Latitude/Longitude	
				Start	End
Item	DWR UCIP Field Study			38.571776 °	38.571776 °
				-121.513364 °	-121.513364 °
DWR ID	DWR_NA0005_01_s_2014_27				
Action/Comments					
Inspector Comments: FS_ID:20093					
EP_NO: 12196					
Repair Type:					
Crossing Status:					
UCIP Comments: Check with City of Sacramento to determine last inspection and condition of crossing. Vegetation on waterward and landward slope makes it difficult to inspect and identify any potential leaks visible from surface.					
FIELD_STRUCT_DESC: 1 of 2: 120-inch RCP outfall pipe extends approximately 117 feet waterward from the reservoir to a reinforced concrete outfall valve structure located in the levee crown. Waterward slope is armored by rock slope protection. Rock slope protection perimeter exists at outlet. (Permit No. 12196, Sacramento Regional County Sanitation District-1977). (Permit No. 12196, Sacramento Regional Sanitation District-1981).

View of landward side--fenced area, walkway, and bldg structure on landward toe.

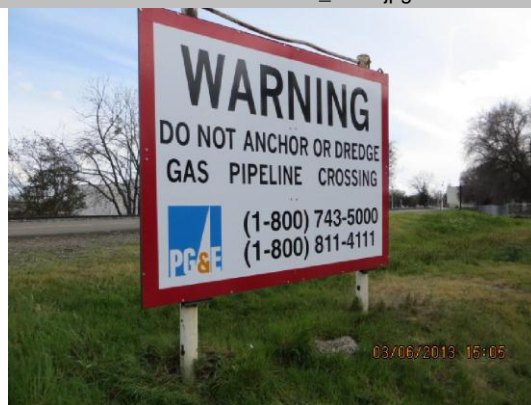
Photo 1 of 1 : UCIP_2224.jpg

LM Start	1.59	Rating **	M	Issue No.	28
LM End	1.59	Issue Type +	En	Location *	CR
Category	Supplemental			GPS Latitude/Longitude	
				Start	End
Item	DWR UCIP Field Study			38.570075 °	38.570075 °
				-121.515402 °	-121.515402 °
DWR ID	DWR_NA0005_01_s_2014_28				
Action/Comments					
Inspector Comments: FS_ID:20387					
EP_NO: 2371					
Repair Type:					
Crossing Status:					
UCIP Comments: Need to coordinate with PG&E to clarify all appurtenances associated with crossing. Need maintenance records for this crossing (last inspection).					
FIELD_STRUCT_DESC: 12-inch pipe through the levee, 5.0 feet below the crown. Gas pipeline sign on the waterward slope and rectangular concrete box on the waterward berm. (Permit No. 2371-PG&E, 1959).					
FS Date: 3/6/1913

PG&E warning gas line crossing--waterward side view.

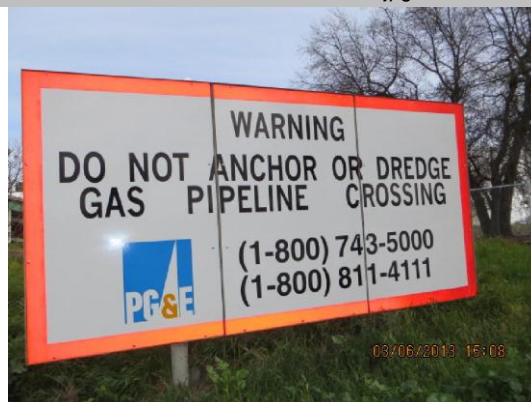
Photo 1 of 1 : UCIP_2230.jpg

LM Start	1.61	Rating **	M	Issue No.	29
LM End	1.61	Issue Type +	En	Location *	CR
Category	Supplemental			GPS Latitude/Longitude	
				Start	End
Item	DWR UCIP Field Study			38.570075 °	38.570075 °
				-121.515546 °	-121.515546 °
DWR ID	DWR_NA0005_01_s_2014_29				
Action/Comments					
Inspector Comments: FS_ID:20388					
EP_NO: 14732					
Repair Type:					
Crossing Status:					
UCIP Comments: Need to obtain maintenance records for pipe line--					
Inspector was able to obtain inspection status from PG&E.					
FIELD_STRUCT_DESC: 24 inch diameter natural gas pipeline under the levee and channel at a depth of 25 feet minimum. (Permit No. 14732, PG&E-1988)					
FS Date: 3/7/1913

Warning sign of gas pipeline crossing located on waterward slope.

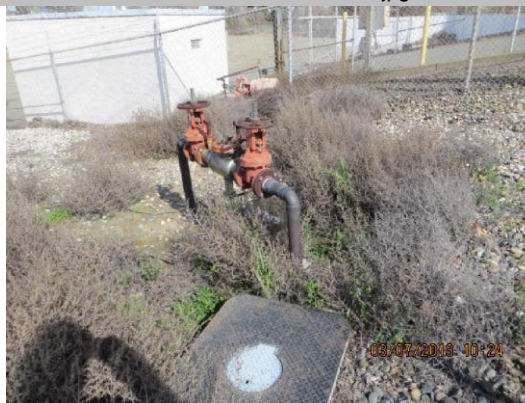
Photo 1 of 1 : UCIP_2397.jpg

LM Start	1.74	Rating **	M	Issue No.	30
LM End	1.74	Issue Type +	En	Location *	CR
Category	Supplemental			GPS Latitude/Longitude	
				Start	End
Item	DWR UCIP Field Study			38.567981 °	38.567981 °
				-121.516077 °	-121.516077 °
DWR ID	DWR_NA0005_01_s _ 2014_30				
Action/Comments					
Inspector Comments: FS_ID:20990					
EP_NO: 9259					
Repair Type:					
Crossing Status:					
UCIP Comments: backflow device next to fence area angled.					
FIELD_STRUCT_DESC: 12-inch cast iron water main pipe sleeved					
through a 20-inch steel casing 3.0 feet below the crown elevation.					
(Permit No. 9259, City of Sacramento-1974)					
FS Date: 3/7/1913

Close up of positive closure device.

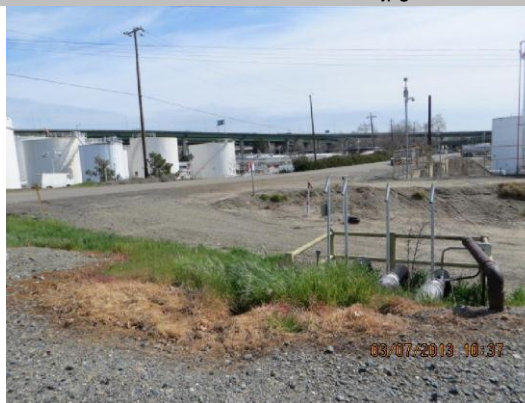
Photo 1 of 1 : UCIP_2411.jpg

LM Start	1.75	Rating **	M	Issue No.	31
LM End	1.75	Issue Type +	En	Location *	CR
Category	Supplemental			GPS Latitude/Longitude	
				Start	End
Item	DWR UCIP Field Study			38.567888 °	38.567888 °
				-121.516082 °	-121.516082 °
DWR ID	DWR_NA0005_01_s _ 2014_31				
Action/Comments					
Inspector Comments: FS_ID:21044					
EP_NO: 8816					
Repair Type:					
Crossing Status:					
UCIP Comments: High rodent on landward side. Dense vegetation limits the inspector's visibility to identify signs of pipe failure (leaks) through the slope. Recommend removing vegetation along pipe alignment to conduct proper inspection of structure and appurtenances.					
FIELD_STRUCT_DESC: 2 of 4: 10 inch line (premium) encased in 16 inch casing approximately 4 feet below crown. Vent pipes installed at each end of the conductor pipe. (Permit No. 8816, Phillips Petroleum Company-1974)					
FS Date: 3/7/1913

Overview of 4-10 inch lines through levee--landward side.

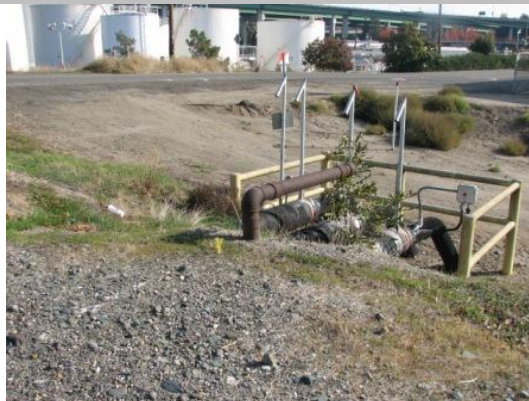
Photo 1 of 2 : johngw_s_20140429_948.jpg

A pipe on the landside shoulder crosses under the railroad tracks. Fall 2011

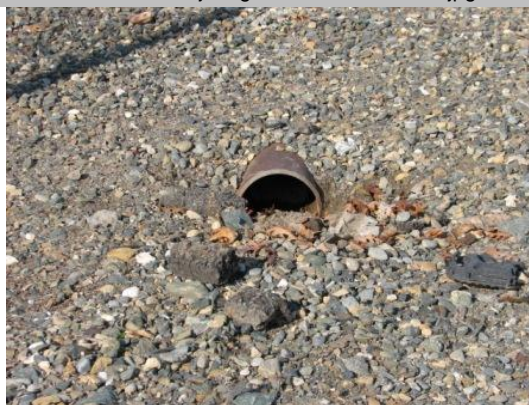
Photo 2 of 2 : johngw_s_20140429_949.jpg

This appears to be a drain pipe under a driveway. It is a different pipe then the other photo for this issue. Fall 2011

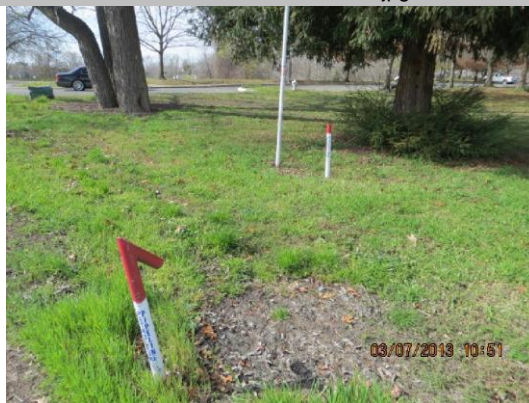
Photo 1 of 1 : UCIP_2429.jpg

LM Start	1.79	Rating **	M	Issue No.	35
LM End	1.79	Issue Type +	En	Location *	CR
Category	Supplemental			GPS Latitude/Longitude	
				Start	End
Item	DWR UCIP Field Study			38.567317 °	38.567317 °
				-121.516154 °	-121.516154 °
DWR ID	DWR_NA0005_01_s _ 2014_35				
Action/Comments					
Inspector Comments: FS_ID:21054					
EP_NO: 4914					
Repair Type:					
Crossing Status:					
UCIP Comments: Need records confirming crossing is free of leaks.					
FIELD_STRUCT_DESC: 8-inch pipe through the levee, 5.0 feet below the crown and along the waterward side to Levee Mile 2.41, for river crossing under the channel. (Permit No. 4914, A, B, C-Standard Oil Co.)					
FS Date: 3/7/1913

View of waterard side--markers visible through levee.

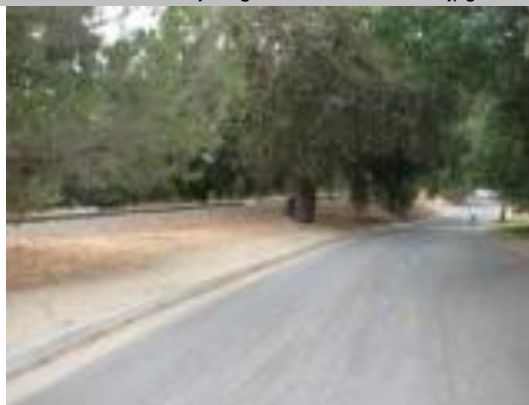
Photo 1 of 2 : johngw_s_20140429_928.jpg

LM Start	1.96	Rating **	M	Issue No.	7
LM End	2.34	Issue Type +	En	Location *	CR
Category	Earthen Levee			GPS Latitude/Longitude	
				Start	End
Item	Encroachments			38.564900 °	38.559460 °
				-121.516253 °	-121.515085 °
DWR ID	DWR_NA0005_01_s _ 2012_7				
Action/Comments					
Equipment					
Inspector Comments: Railroad tracks run on crown of levee, paved roadway runs along toe on waterside. This is Miller Park Marina area.

Railroad tracks are on levee crown. The street is to the boat ramp.

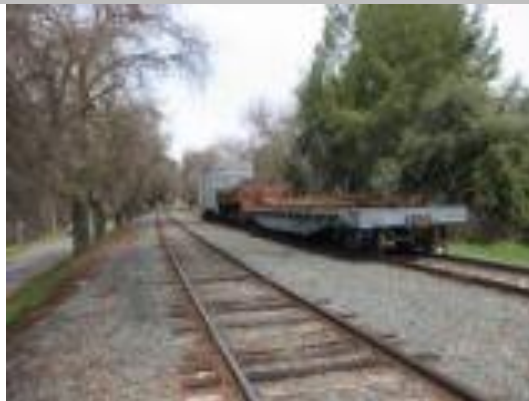
Photo 2 of 2 : johngw_s_20140429_929.jpg

The railroad cars remain on the levee crown. Spring 2013

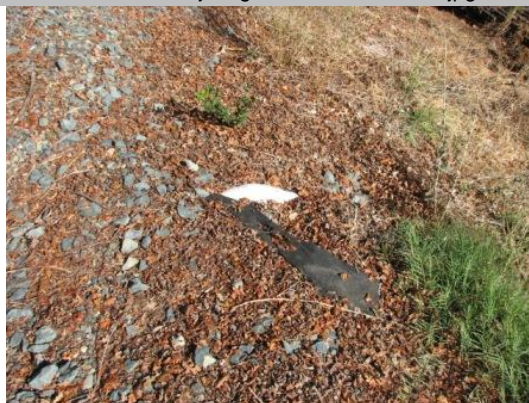
Photo 1 of 1 : johngw_s_20140429_950.jpg

LM Start	2.04	Rating **	A/W	Issue No.	145
LM End	2.04	Issue Type +	Ma	Location *	CR
Category	Earthen Levee			GPS Latitude/Longitude	
				Start	End
Item	Encroachments			38.563720 °	-121.515890 °
				38.563720 °	-121.515890 °
DWR ID	DWR_NA0005_01_s _ 2012_145				
Action/Comments					
Pipe					
Inspector Comments: The pipe has been repaired by the LMA. The pipe was installed by the Railroad Museum and is in talks with the CVFPB. No permit was issued for them.

The pipe is a french drain under the railroad tracks. Was in the USACE report has not been resolved. Photo fall 2012.

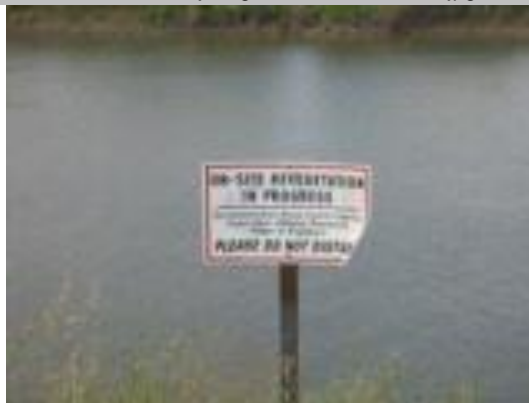
Photo 1 of 2 : johngw_s_20140429_945.jpg

This area is a revegetation site, photo taken spring 2012.

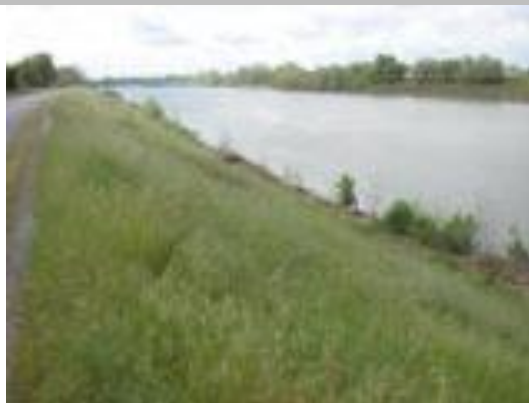
Photo 2 of 2 : johngw_s_20140429_946.jpg

A photo of the revegetation site taken spring 2012.

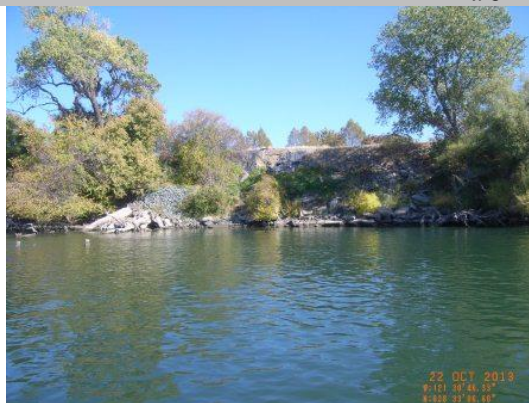
Photo 1 of 1 : USACE2013A_SAC_56-6_L_2.jpg

LM Start	2.84	Rating **	M	Issue No.	11
LM End	2.84	Issue Type +	Ma	Location *	WS
Category	Supplemental			GPS Latitude/Longitude	
				Start	End
Item	USACE Erosion Survey			38.551578 °	38.552268 °
				-121.512336 °	-121.512590 °
DWR ID					
Action/Comments					
Inspector Comments: 1997 - Erosion at pump station, concrete debris

USACE 2013 Photo #1

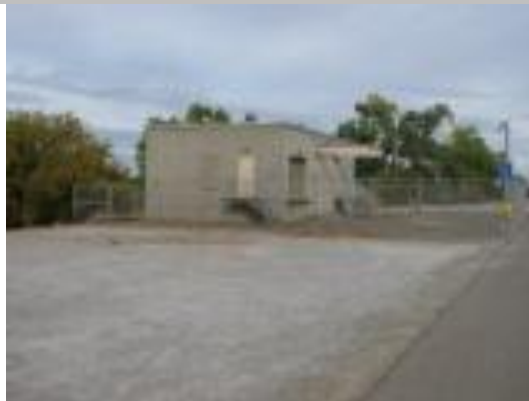
Photo 1 of 1 : johngw_s_20140429_931.jpg

City of Sacramento pump station on the waterside of the crown of the levee.

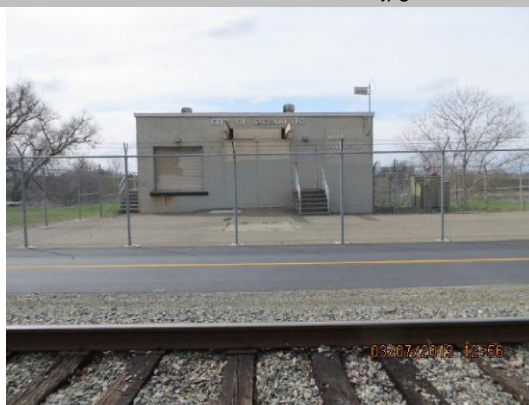
Photo 1 of 1 : UCIP_2440.jpg

LM Start	2.91	Rating **	M	Issue No.	36
LM End	2.91	Issue Type +	En	Location *	CR
Category	Supplemental			GPS Latitude/Longitude	
				Start	End
Item	DWR UCIP Field Study			38.551674 °	38.551674 °
				-121.511782 °	-121.511782 °
DWR ID	DWR_NA0005_01_s _ 2014_36				
Action/Comments					
Inspector Comments: FS_ID:21065					
EP_NO: 2043					
Repair Type:					
Crossing Status:					
UCIP Comments: This crossing has been abandoned. According to City of Sacramento Staff the last time this crossing was fired up to see if it was functioning was 3 years ago.					
FIELD_STRUCT_DESC: Ranney collector on waterward slope. Ranney collector with 24 inch discharge pipe through levee. (Permit No. 2043, City of Sacramento-1955).					
FS Date: 3/7/1913

Ranney collector facility operated by the City of Sacramento.

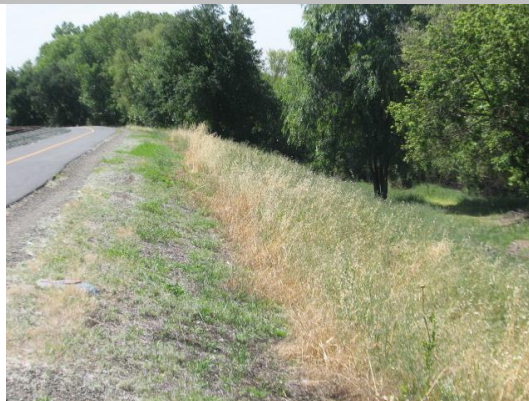
Photo 1 of 1 : johngw_s_20140502_964.jpg

The tall grasses partially blocks visibility. Spring 2014

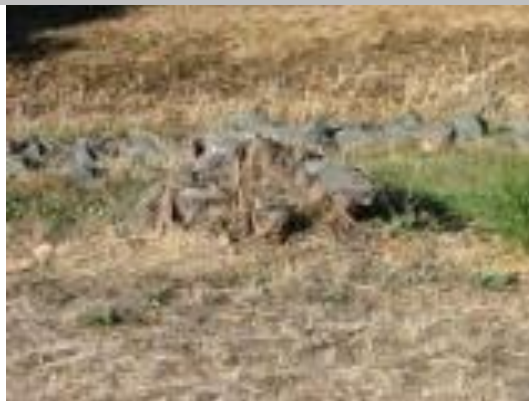
Photo 1 of 1 : johngw_s_20140429_944.jpg

LM Start	3.22	Rating **	N	Issue No.	16
LM End	3.22	Issue Type +	Ma	Location *	WS
Category	Earthen Levee			GPS Latitude/Longitude	
				Start	End
Item	Trim / Thin Trees			38.547353 °	38.547353 °
				-121.510253 °	-121.510253 °
DWR ID	DWR_NA0005_01_f_2012_16				
Action/Comments					
Tree stumps.

There are several tree stumps in this area. The district have been monitoring and spraying the stumps. Photo fall 2012.

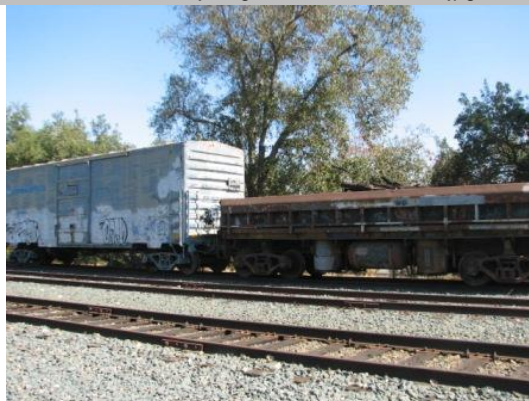
Photo 1 of 1 : johngw_s_20140429_930.jpg

LM Start	3.29	Rating **	M	Issue No.	9
LM End	3.29	Issue Type +	En	Location *	CR
Category	Earthen Levee			GPS Latitude/Longitude	
				Start	End
Item	Encroachments			38.546302 °	38.546302 °
				-121.510197 °	-121.510197 °
DWR ID	DWR_NA0005_01_f_2013_9				
Action/Comments					
Equipment					
Inspector Comments: There is four cars on the levee crown.

Trains cars are stored on the crown of the levee. Fall 2013

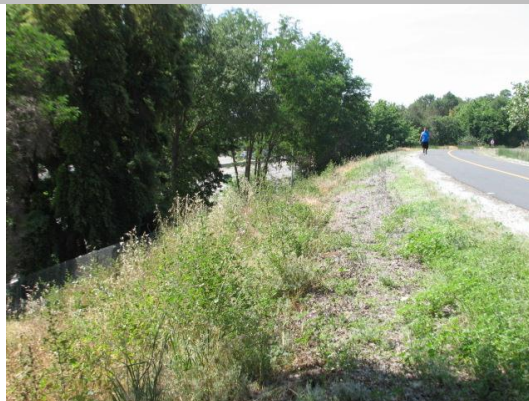
Photo 1 of 1 : johngw_s_20140502_965.jpg

Tall grasses partially blocks visibility. Spring 2014

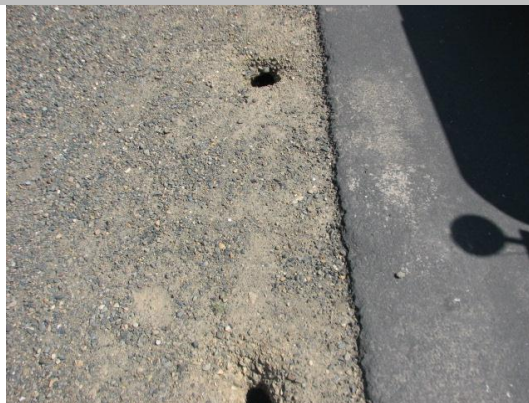
Photo 1 of 1 : johngw_s_20140502_966.jpg

LM Start	3.47	Rating **	M	Issue No.	39
LM End	3.47	Issue Type +	Ma	Location *	CR
Category	Earthen Levee			GPS Latitude/Longitude	
				Start	End
Item	Animal Control			38.543351 °	38.543351 °
				-121.510084 °	-121.510084 °
DWR ID	DWR_NA0005_01_s _ 2014_39				
Action/Comments					
No rodents visible, but rodent burrows visible; need to backfill and compact or grout burrows.

A couple of rodent holes on the waterside of the crown. Spring 2014
